**BIG TURKEY LAKE WATERSHED
FEASIBILITY STUDY**

**LAGRANGE, STEUBEN, DEKALB,
AND NOBLE COUNTIES, INDIANA**

September 5, 2002

Prepared By:
J.F. New & Associates, Inc.
708 Roosevelt Road
Walkerton, IN 46574
(574) 586-3400

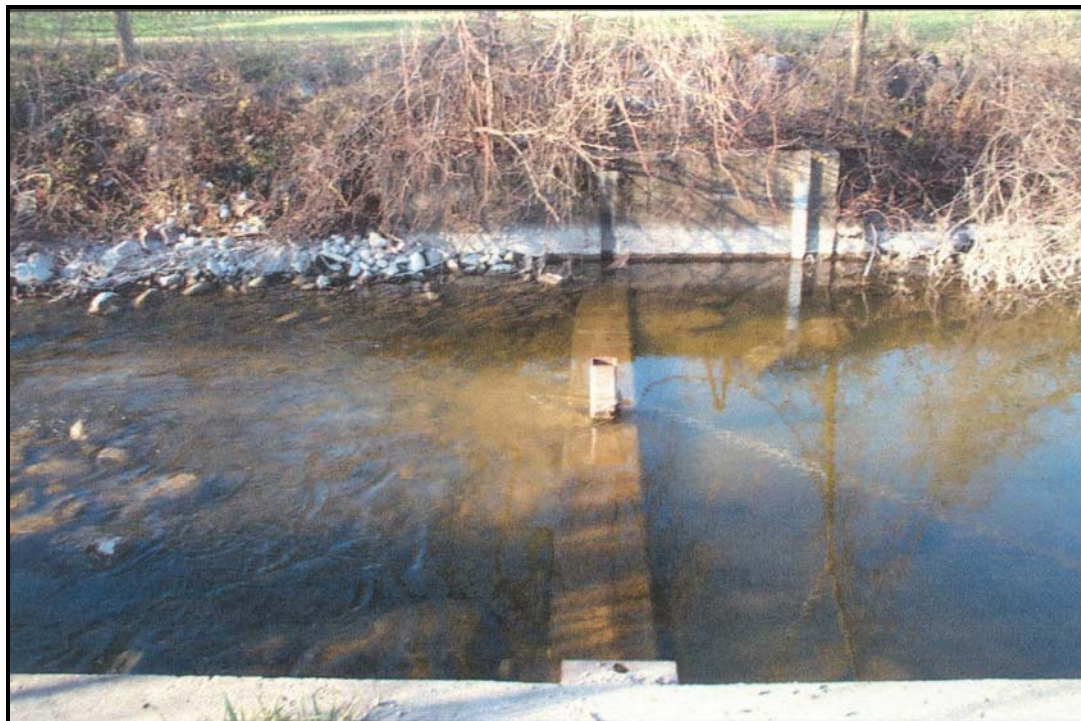
FIGURE 8. Existing concrete spillway at County Road 1175 East.

Raising the lake's water level is relatively easy. By placing boards in existing I-beams located on the spillway structure, the lake level can be easily manipulated (Figure 8). The state could use the water control structure to manipulate the maximum lake level and draw down the lake level if necessary.

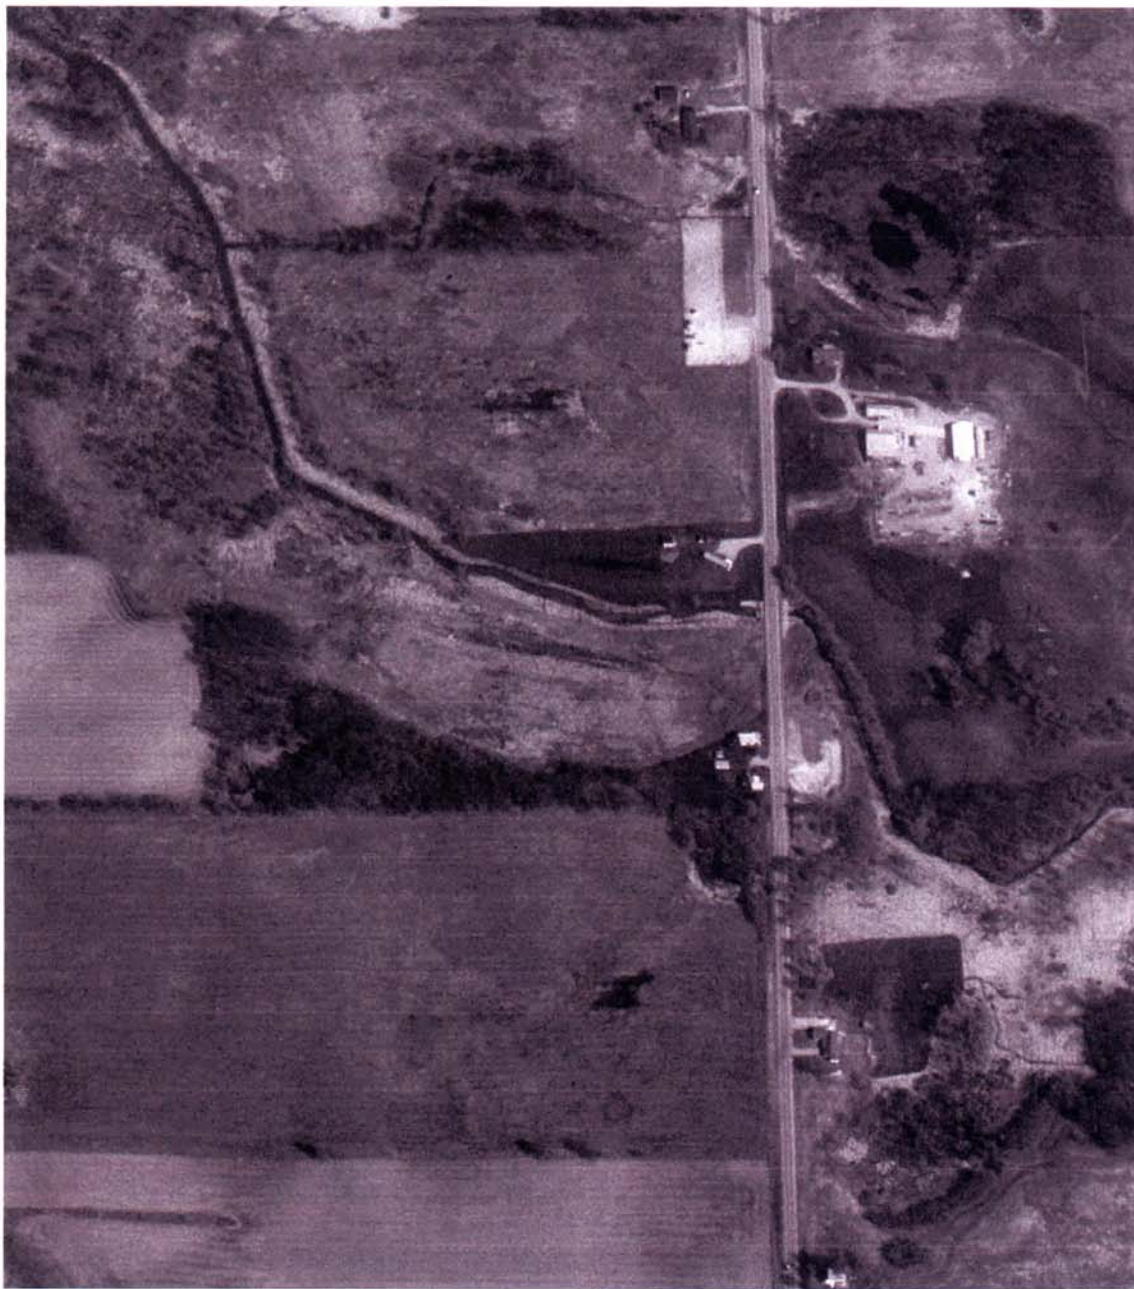
Proposed Wetland Location 1 (Harza, 1990)
Big Turkey Lake Watershed Feasibility Study
Lagrange, Steuben, Dekalb and Noble Counties, Indiana

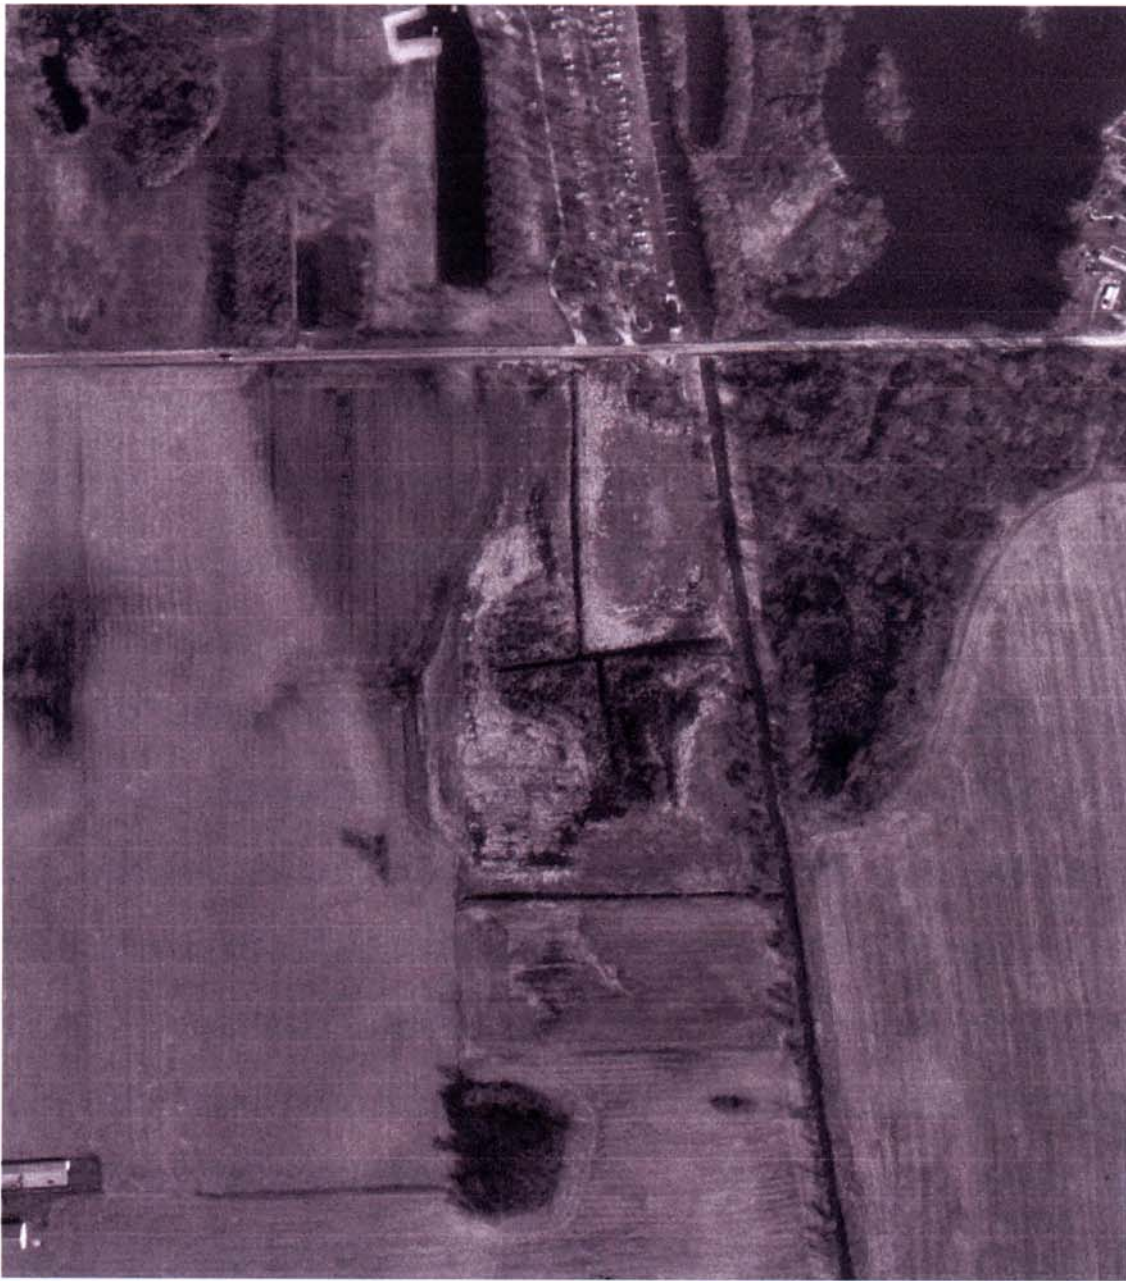
Proposed Wetland Location 2 (Harza, 1990)
Big Turkey Lake Watershed Feasibility Study
Lagrange, Steuben, Dekalb, and Noble Counties, Indiana

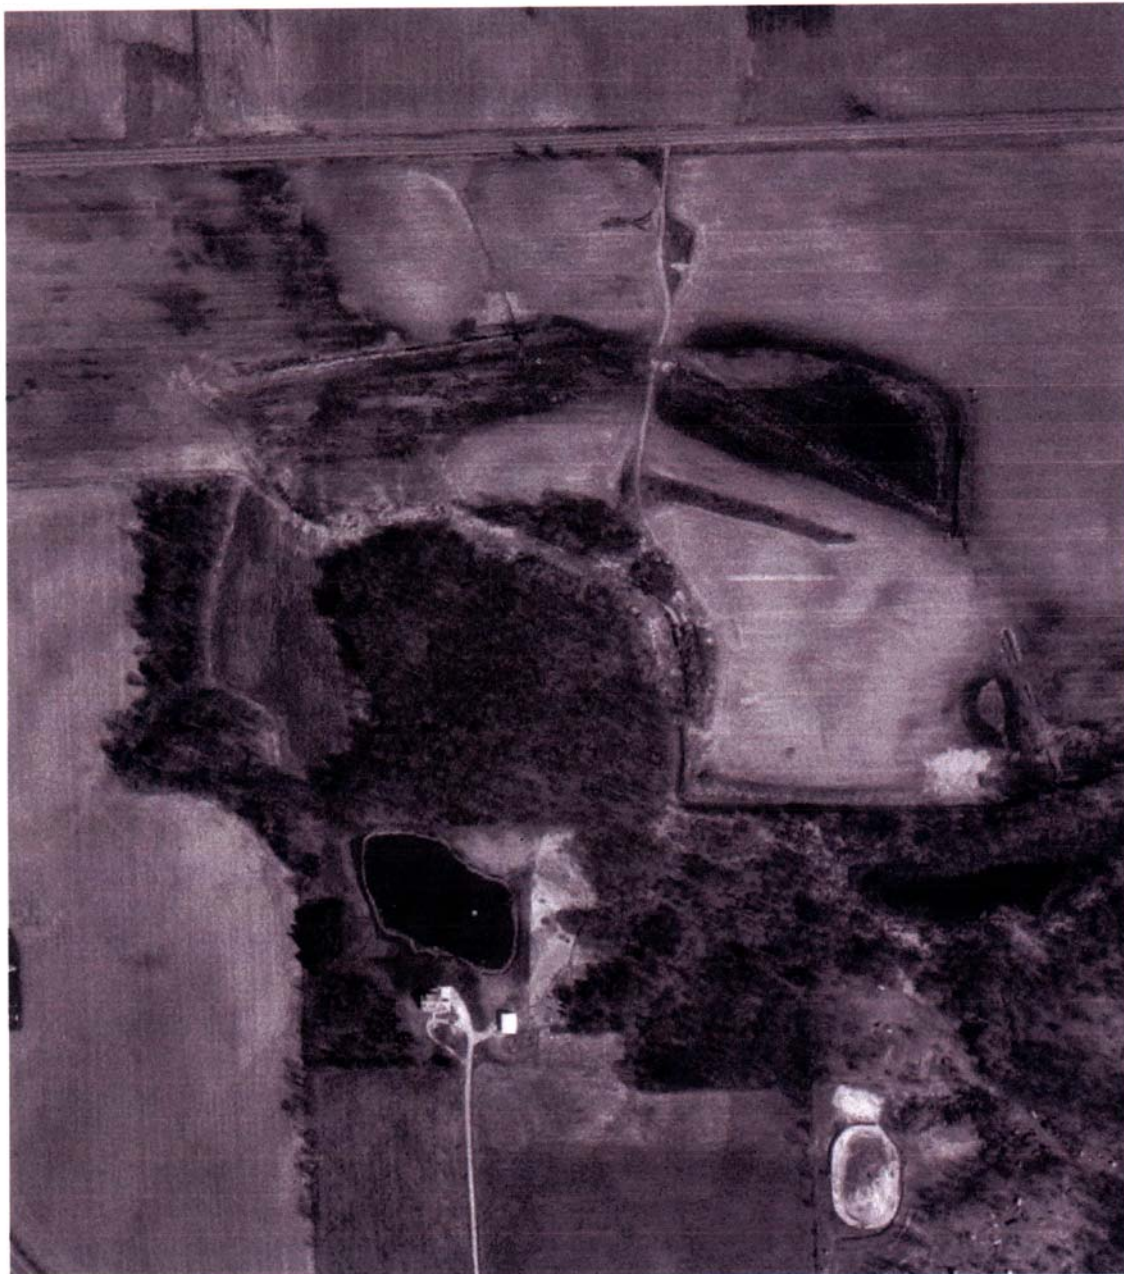
Proposed Wetland Location 3a (Harza, 1990)
Big Turkey Lake Watershed Feasibility Study
Lagrange, Steuben, Dekalb and Noble Counties, Indiana

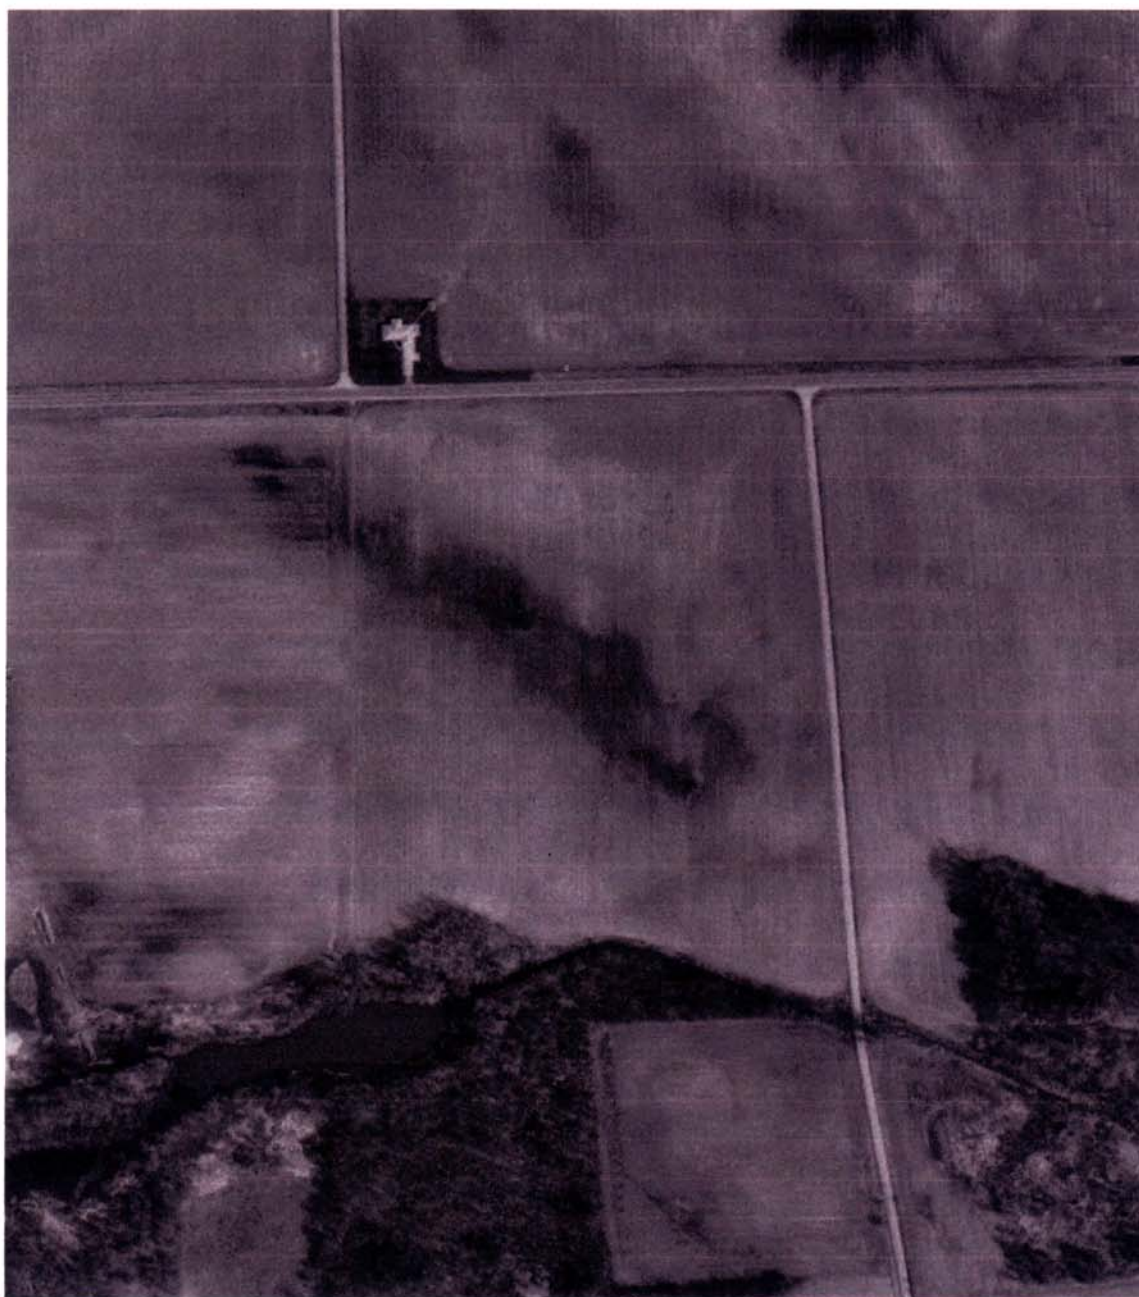
Proposed Wetland Location 3b (Harza, 1990)
Big Turkey Lake Watershed Feasibility Study
Lagrange, Steuben, Dekalb and Noble Counties, Indiana

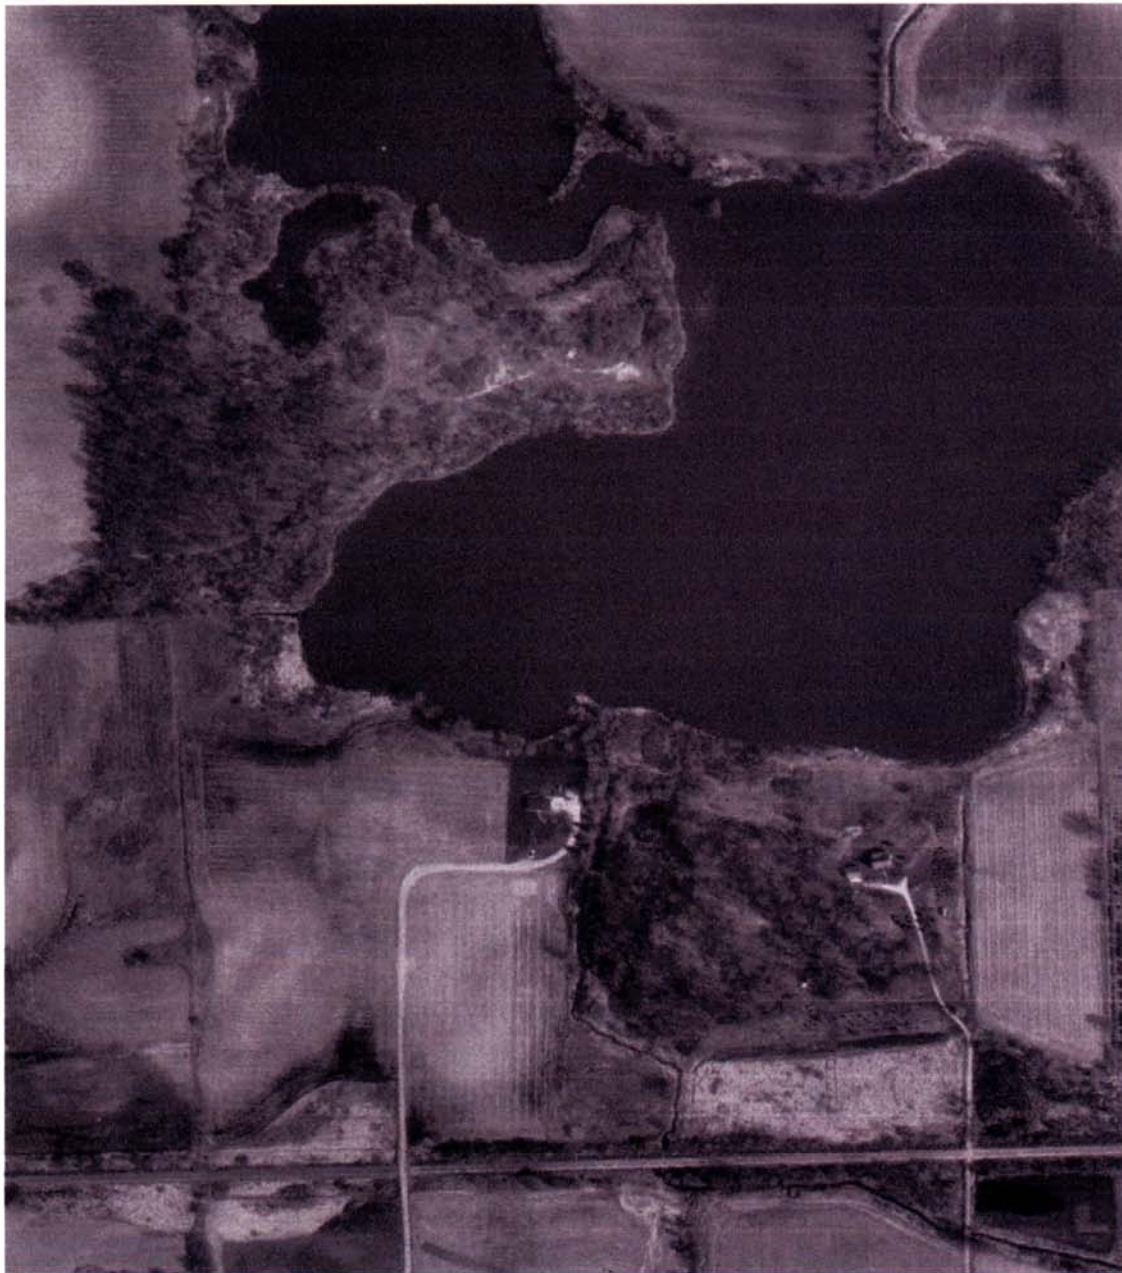
Proposed Wetland Location 5 (Harza, 1990)
Big Turkey Lake Watershed Feasibility Study
Lagrange, Steuben, Dekalb and Noble Counties, Indiana

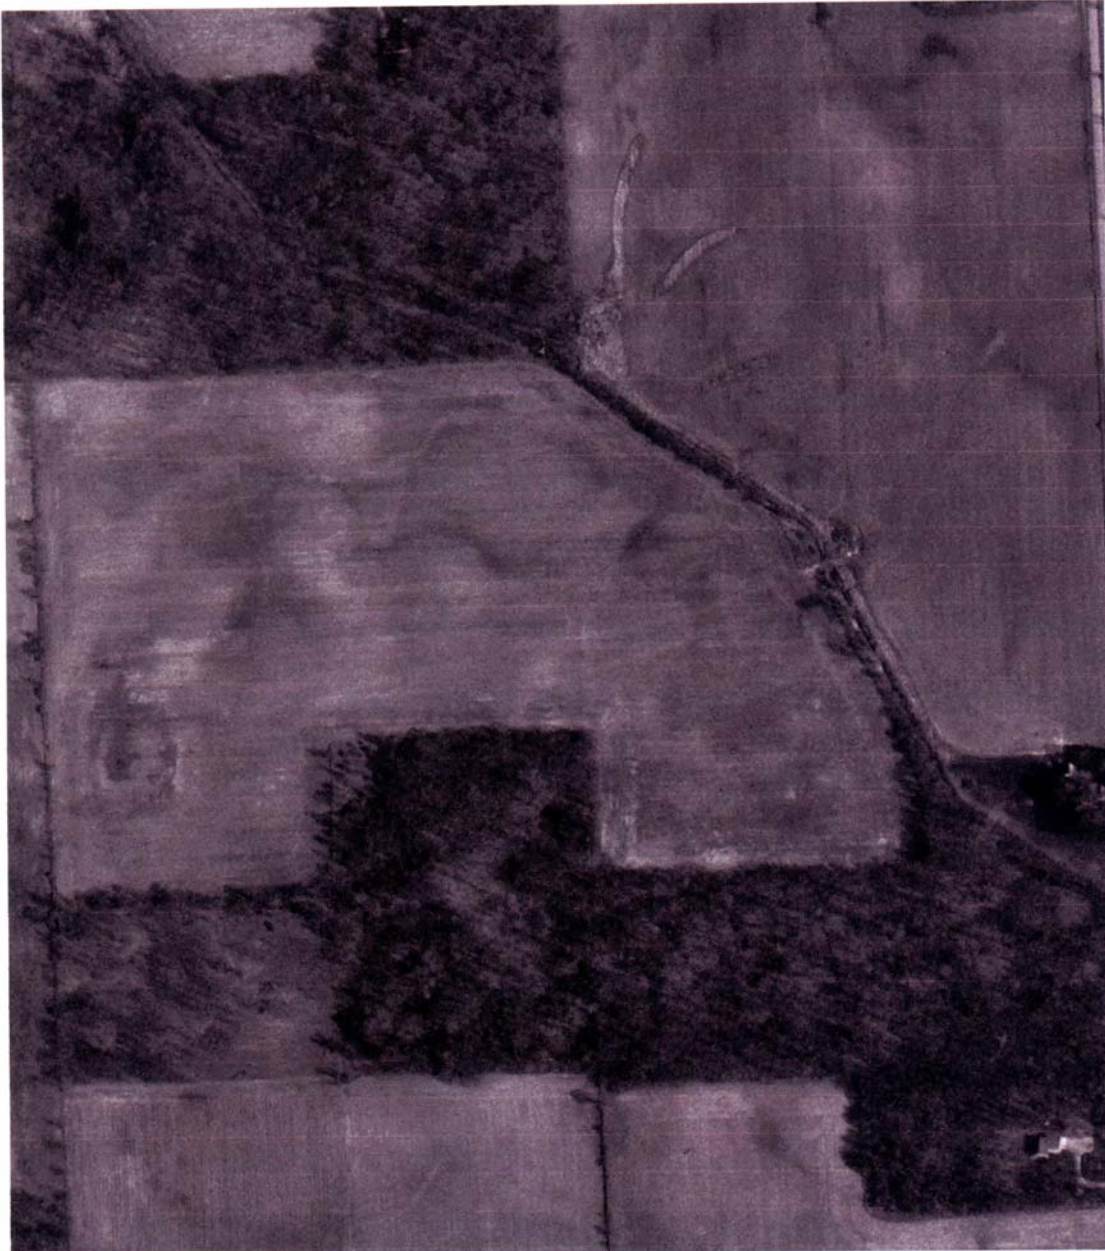
Proposed Wetland Location 6 (Harza, 1990)
Big Turkey Lake Watershed Feasibility Study
Lagrange, Steuben, Dekalb and Noble Counties, Indiana

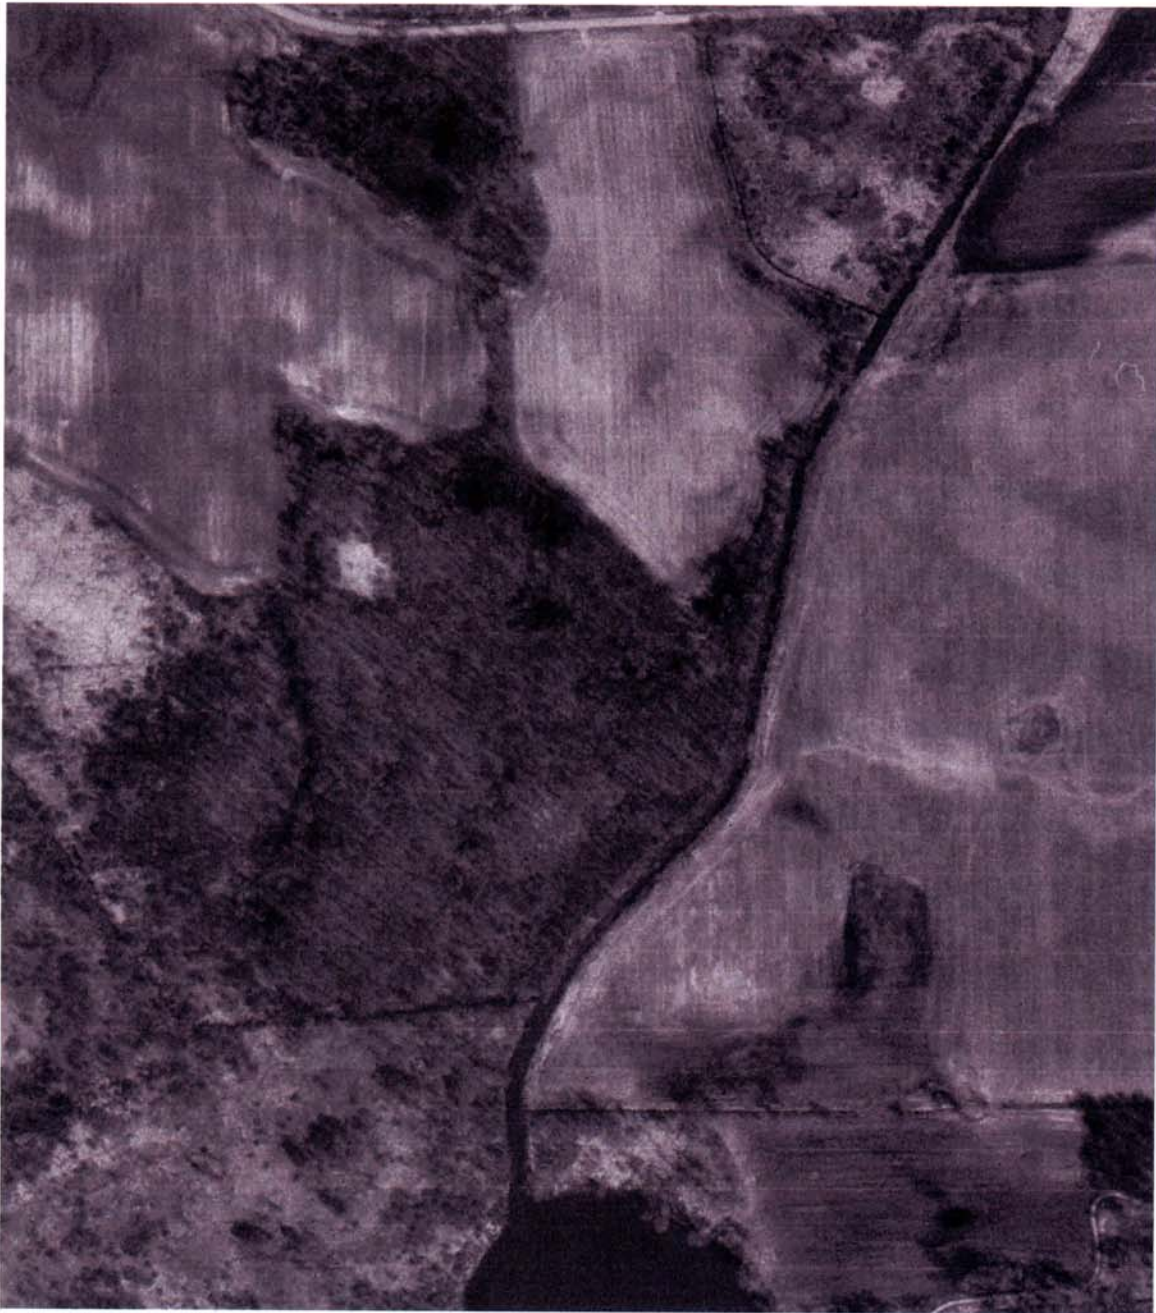
Proposed Wetland Location 7 (Harza, 1990)
Big Turkey Lake Feasibility Study
Lagrange, Steuben, Dekalb, and Noble Counties
